Inspection Report
Minerals Regulatory Program
July 21, 2005

Mine Name: Bingham Canyon Mine - North Tailings
Impoundment - Barneys Canyon
Operator Name: Kennecott Utah Copper - Kennecott Barneys Canyon Mining
Inspector(s): Doug Jensen, Paul Baker, Tom Munson, Beth Erickson, Mary Ann Wright, Mark Mesch, Joelle Burns, Daron Haddock
Other Participants: Vicky Peacey, Paula Doughty, Kelly Payne - KUC - Environmental
Alex Reynoso, Denise Powers, Doug Stauffer, Jason Nielson - KUC - North Impoundment
Ray Gottling - Kennecott Barneys Canyon Mining
Ed Park, Glen Lovendahl - KUC Operations - Bingham Canyon Mine
Mine Status: Active
Permit numbers: M/035/002 - M/035/009 - M/035/015
Inspection Date: July 20, 2005
Time: 8:00 AM - 4:00 PM
Weather: Hot, Sunny

This was the Division's annual inspection tour of Kennecott's operations.

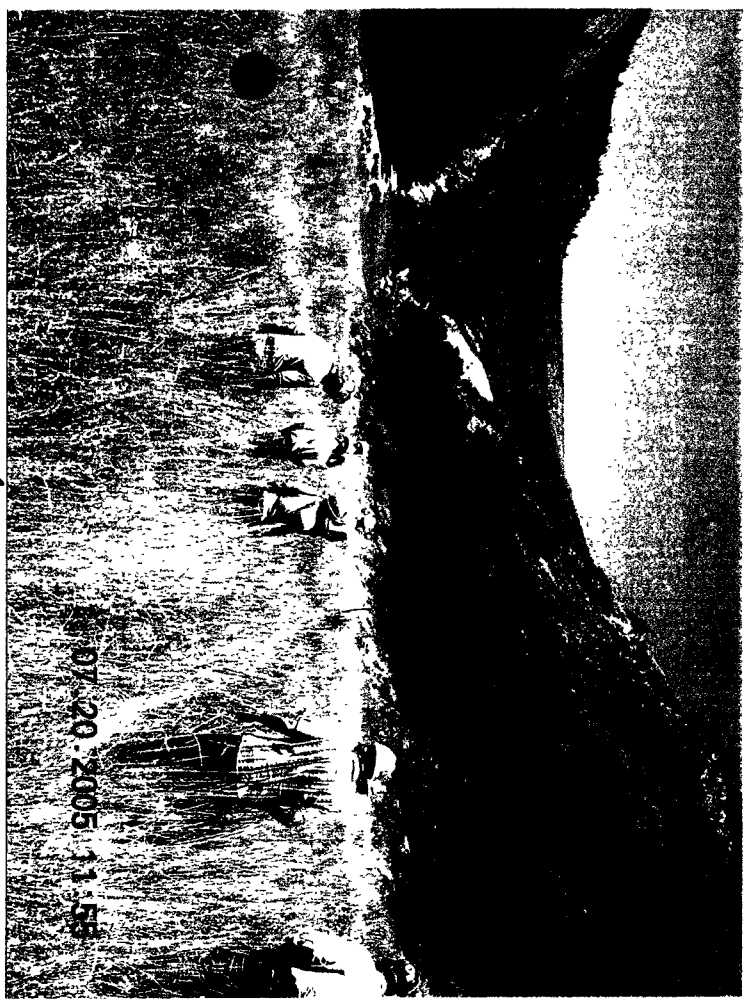
DSCN1163.JPG 2005/07/20 13:41:03

The next area we visited was a dump area below the mine access road that was regraded in 2004. This is a small area (~20 acres) in an area where the material not only had to be pushed down, but a portion of the material had to be pushed laterally because of location of the mine access road, which is located directly above this area. The slope was finished with some undulation and considering the work involved to attain the slope, it looked good. Kennecott should be applauded for spending the time necessary to make the slope look more natural. The slope had been ripped after the recontouring effort was completed. No revegetation effort has been made in this area due to the overall pH of the slope being ~3.2. Therefore, seeding of this area at this time would have a greater chance of failing than succeeding.

BARNES CANYON BELEG
v BINGHAM MINE MAIN ACCESS ROAD DUMP RESTORING

I suggested that the area be allowed to weather awhile before attempting to seed it. Allowing the final slope to weather for a period should result in the reduction of the sulphides in the material, which would result in a moderation of the pH.
